MISCELLANEOUS PAPER S-73-22

CONDITION SURVEY, MALMSTROM AIR FORCE BASE, MONTANA

R. D. Jackson

April 1973

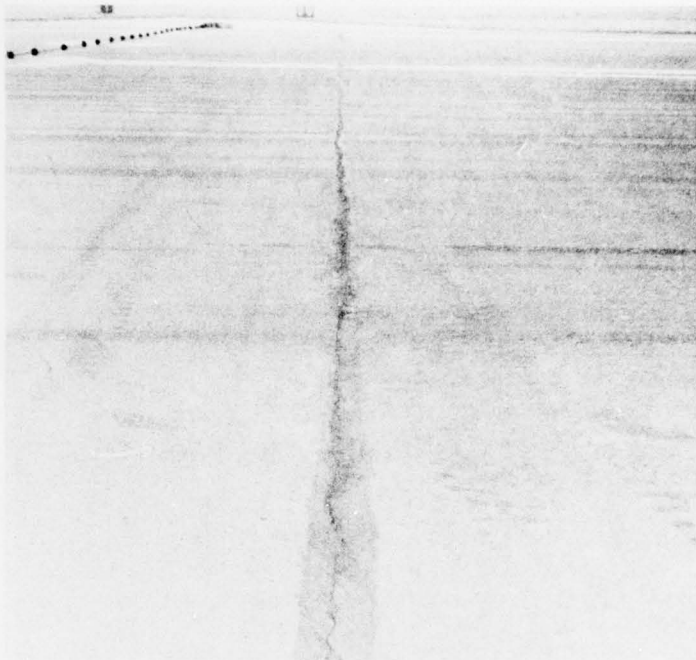
was in very good condition. The first 1000 ft of the NE (20) end (features R1A and R2B), which is also 16-in. PCC, was in excellent structural condition, and no major defects were noted. The joint sealing materials on both 1000-ft runway ends were in very poor condition and had completely deteriorated between several slabs at the southwest end. The asphaltic-concrete (AC) portion of the runway was in good condition, even though there were numerous longitudinal and transverse cracks that appeared to be reflection cracks (photos 1 and 2).

Photo 1. Transverse crack in runway near NE end

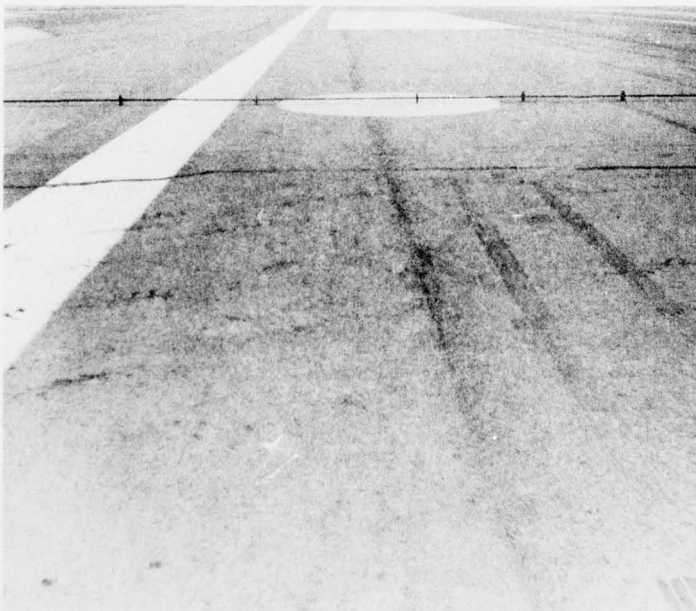
Photo 2. Longitudinal and transverse cracks
near NE end of runway

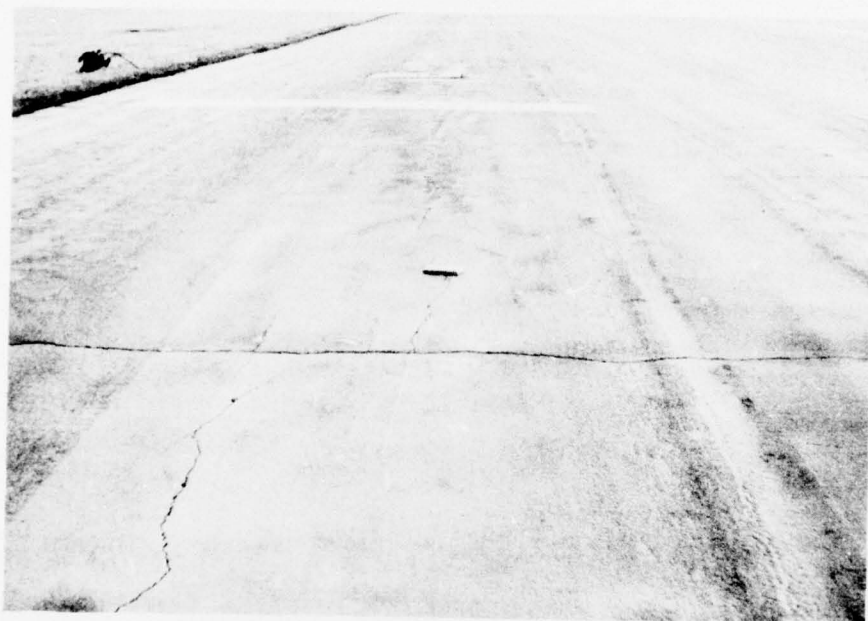
23. The runway overruns were smooth and showed no evidence of frost heaving. (The combined thickness of the overrun pavement is 65 in., while that of the adjacent rigid pavement is only 36 in.) The taxiway and apron shoulders showed considerable unevenness in many areas, with some longitudinal and transverse cracks, particularly in taxiways T, S, R, and Q and in the southwest warm-up apron (see photos 4 and 5). The roughness was probably the result of frost heaving, while much of the cracking was probably the result of vehicular traffic.

Photo 5. Taxiway T shoulder pavement
